A Reconfigurable Motor for Experimental Emulation of Stator Winding Interturn and Broken Bar Faults in Polyphase Induction Machines

Abstract—The benefits and drawbacks of a 5-hp reconfigurable induction motor, which was designed for experimental emulation of stator winding interturn and broken rotor bar faults, are presented in this paper. It was perceived that this motor had the potential of quick and easy reconfiguration to produce the desired stator and rotor faults in a variety of different fault combinations. Hence, this motor was anticipated to make a useful test bed for evaluation of the efficacy of existing and new motor fault diagnostics techniques and not the study of insulation failure mechanisms. Accordingly, it was anticipated that this reconfigurable motor would eliminate the need to permanently destroy machine components such as stator windings or rotor bars when acquiring data from a faulty machine for fault diagnostic purposes. Experimental results under healthy and various faulty conditions are presented in this paper, including issues associated with rotor bar-end ring contact resistances that showed the drawbacks of this motor in so far as emulation of rotor ba

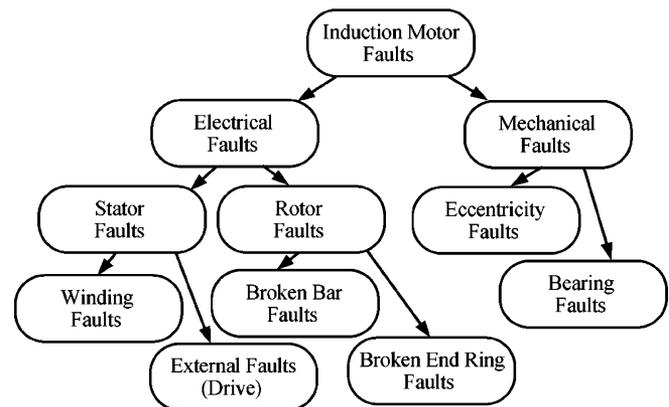
Fig. 1. Induction motor fault categories.

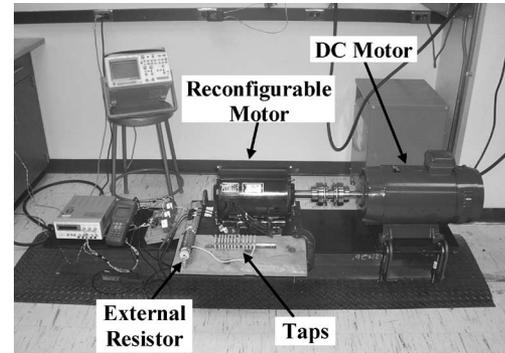
Fig. 2. Experimental setup.

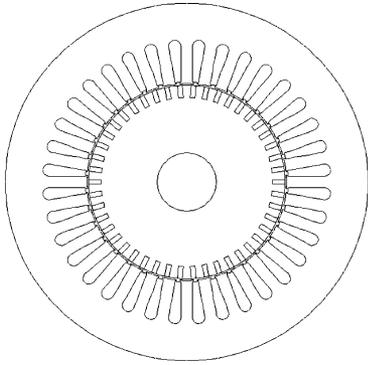
Fig. 3. Cross-sectional view of 5-hp reconfigurable motor.

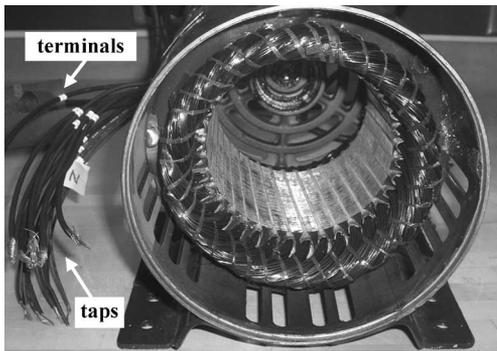
Fig. 4. Skewed stator with winding coils and taps.

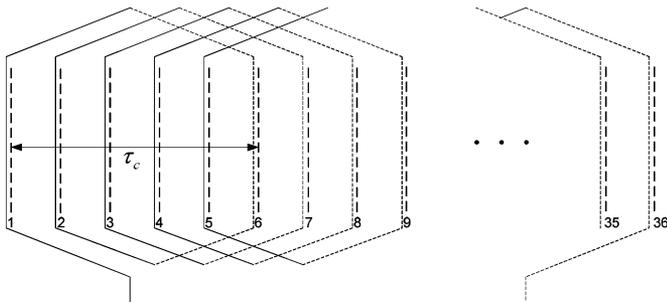
Fig. 5. Stator winding layouts with short-pitched coils.

short-pitched coils, each with a span of $150^\circ e$ (see Fig. 5). The reason for skewing the stator and not skewing the rotor was to facilitate/ease the dismantling of the rotor cage bars when necessary for rotor fault emulation purposes.

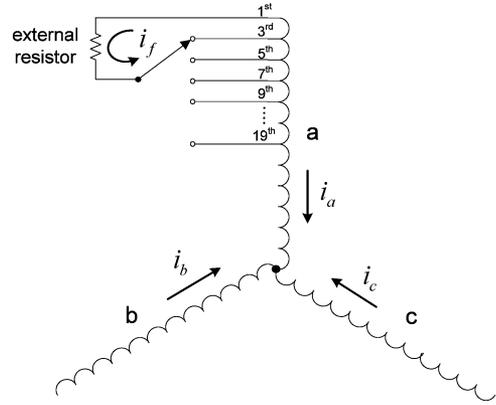
Fig. 6. Schematic diagram of stator windings with taps.

In order to emulate stator interturn short-circuit faults, the motor had a phase winding that was prepared with taps for purposes of “experimental mimicking” of incipient interturn faults. Here, incipient stator faults have been emulated by varying the resistance between the taps, and consequently, varying the magnitude of the circulating fault current. Hence, in this approach, physical mechanisms of insulation failure are not emulated but rather the effects of partial insulation failure prior to a complete insulation breakdown are considered. In this approach, the condition of the stator winding insulation is evaluated based on the

magnitude of the circulating fault current only in the very early stages of insulation weakening. No attempt at the study of the progression of insulation failure was intended here. Ten taps were soldered sequentially every two turns, beginning with the “start” point of turn #1 and ending with the “start” point of turn #19 in only one phase of the machine (see the schematic winding diagram of Fig. 6). The limited number of taps to be soldered in the windings is restricted by the amount of space available inside the motor housing. These taps are specially added at the motor terminal of one of the phases since the stator faults are likely to occur closest to the terminal end of the windings due to insulation stresses caused by the high switching effects from pulsewidth-modulated (PWM) drives [18]. To limit the short-circuit loop current, a variable external resistor was connected between the taps of the shorted portion of the winding turns (see Fig. 6). The design characteristics of this reconfigurable induction motor are given in Table II.

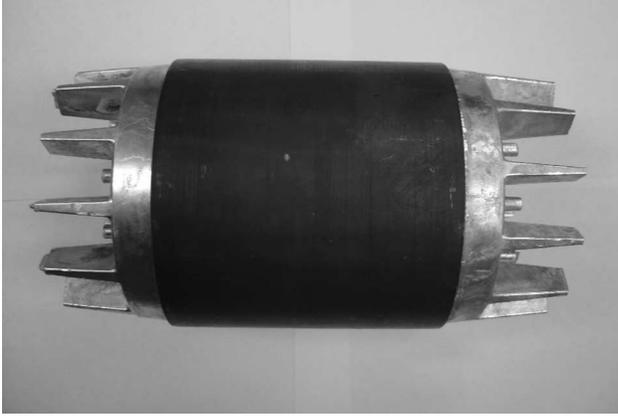
Fig. 7. Die-cast squirrel-cage rotor.

A production-type aluminum die-cast squirrel-cage, see Fig. 7, was prototyped for use with this motor to help collect a baseline healthy performance experimental database. Previous efforts for emulating broken rotor bar faults have required different rotor bars to be broken by drilling out portions of such

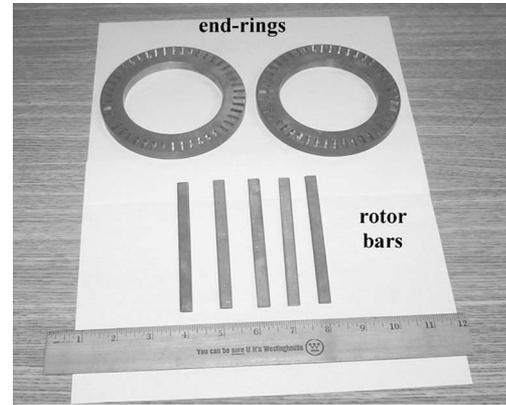
Fig. 8. Rotor bars and end rings.

The core was manufactured from the same type of steel laminations that were used to manufacture the stator core. As mentioned before, for the convenience of inserting the rotor bars into the lamination stack, the rotor core was not skewed. Again, in order to eliminate any cogging effect present in the motor torque due to space harmonic effects, the stator core, as mentioned before, was skewed by one stator slot pitch of 30° . Since the rotor core was not skewed, the rotor bars were accordingly designed to have a layout parallel to the axis of rotation, and they were fabricated from a copper alloy (see Figs. 8 and 9). The rotor end rings were also made of the same material as the rotor bars, and the geometry of the end rings were designed with an outer diameter equal to that of the rotor core. The design was conceived in such a manner that it allows the end rings to be removed, and hence, the rotor bars become easily accessible for removal or insertion from or into the rotor slots. Due to the fact that the rotor bars are not welded to the end rings, such as in typical motor designs, the slots of the end rings were generously coated with conductive grease to ensure a good electrical conduction path to the bars. The rotor bars and the end rings as well as the complete rotor are depicted in Figs. 8 and 9, respectively. In this reconfigurable motor, there are a total of 46 rotor bars.

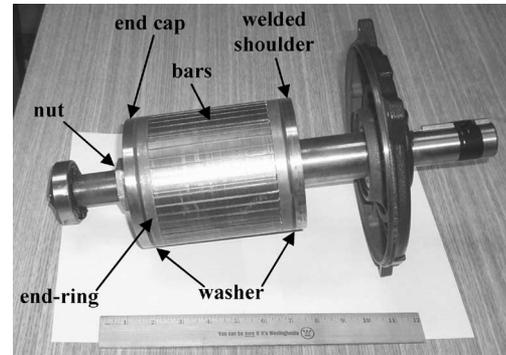
Fig. 9. Reconfigurable squirrel-cage rotor.

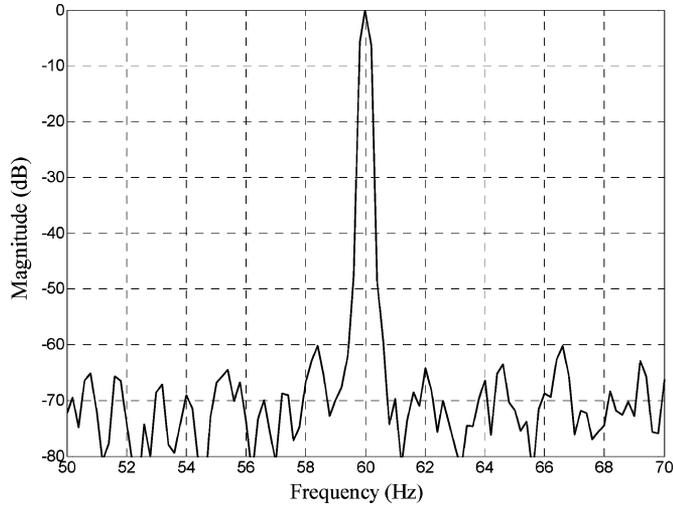
Fig. 10. Phase current FFT of healthy die-cast rotor cage.

The motor was tested at full load and rated frequency using the die-cast squirrel-cage rotor. It should be mentioned that the motor was energized from an open loop (constant volts per hertz) commercially available PWM-inverter drive. The resulting FFT spectrum of its stator current waveform is given in Fig. 10. Its corresponding profile of the magnetic field pendulous oscillation, which is the time-domain profile of the angle between the current and voltage space vectors at the motor terminals, [7]–[9] is given in Fig. 11. For completeness and convenience of the reader, the magnetic field pendulous oscillation angle $\delta(t)$ associated with broken rotor bars or rotor conduction defects is a function of time, and is the instantaneous phase angle difference between the motor's stator voltage space vector \vec{v}_s and the stator current space vector \vec{i}_s . Accordingly, $\delta(t) = \angle \vec{v}_s - \angle \vec{i}_s$, while the so-called swing angle $\Delta\delta_1 = \delta_{\max} - \delta_{\min}$ is the peak-to-

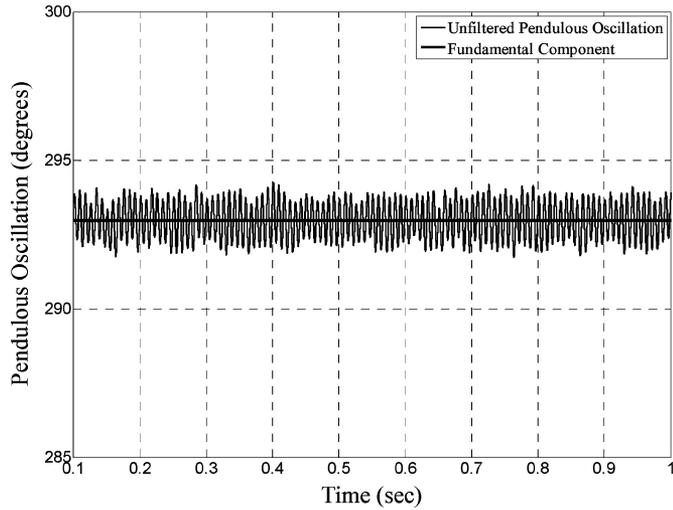
Fig. 11. Healthy die-cast rotor cage pendulous oscillation.

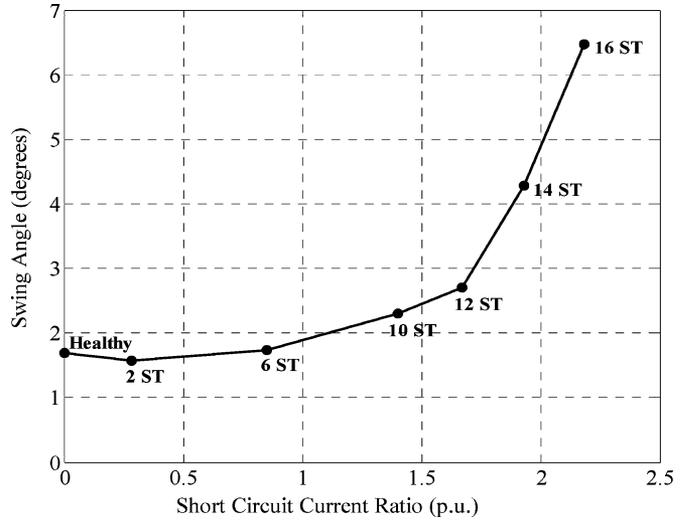
Fig. 12. Swing angle $\Delta\delta_1$ versus the short-circuit current ratio I_f/I_p .

In order to verify the motor performance under interturn short-circuit fault conditions, two fault diagnostic techniques, namely the pendulous oscillation phenomenon [7]–[9] and the negative sequence component concept [1]–[3], were utilized. As reported in [9], the range of the pendulous oscillation (swing angle) progressively increases with an increase in the number of STs, provided that the amplitude of the circulating loop (fault) current I_f exceeds the amplitude of the line current I_a (or the positive sequence component of stator currents I_p). This progressive increase in the swing angle magnitude $\Delta\delta_1$ with the number of STs can be observed in Fig. 12 and Table III. Note that in Fig. 12, the swing angle $\Delta\delta_1$ is plotted with respect to the

circulating loop current ratio I_f/I_a (or I_f/I_p). A similar trend can also be observed using the negative sequence component concept [1]–[3] as illustrated in Fig. 13 and Table III. Note that in Fig. 13, the magnitude of the negative sequence component of stator currents I_n progressively increases with an increase in the number of STs, if and only if the circulating loop current exceeds the line current. It is of importance to mention that the swing angle and the negative sequence current component are nonzero under a healthy condition due to the inherent motor manufacturing imperfections that resulted in slight unbalances in the motor phase a , b , and c currents. From these test results, one can conclude that the reconfigurable motor has the capability of emulating stator winding interturn faults.

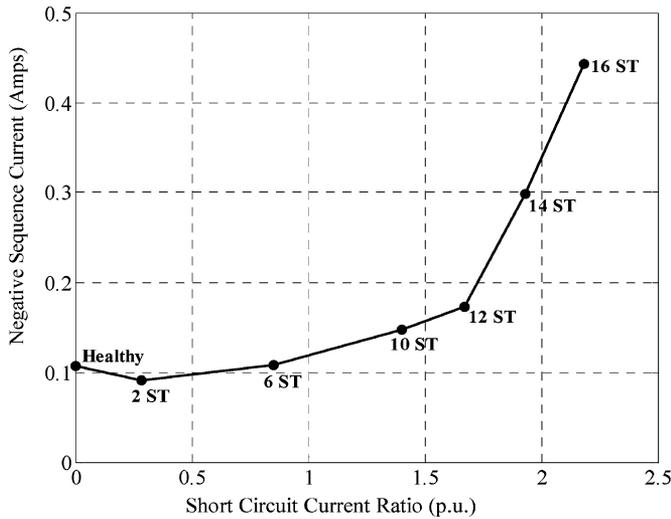
Fig. 13. Negative sequence current I_n versus the short-circuit current ratio I_f/I_p .

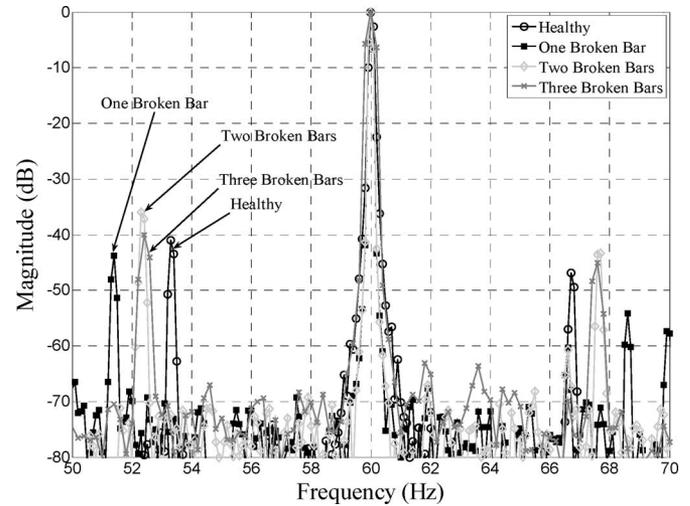
Fig. 14. Phase current FFT of healthy, one broken bar, two broken bars, and three broken bars.

The FFT spectra of the motor phase currents corresponding to different fault scenarios were obtained by the removal of one, two, or three bars from the reconfigurable cage. These FFT spectra are depicted in Fig. 14. The fact that the sideband components did not follow the expected pattern of an increase in their magnitude with a corresponding increase in the number of bars removed from the cage can be attributed to the fact that the quality of the surface contact resistances between the end rings and the bars could not be guaranteed in their consistency. Therefore, these contact resistances change from case to case because of the required disassembly of the rotor cage between the conduction of the various tests in the laboratory. Upon close examination of the location of the LSB frequencies $(1 - 2s)f$ in Fig. 14, for one, two, and three removed bar tests, emulating one, two, and three bar breakages, it is found that the values of the specific LSB frequencies for each of these cases are different from one another. This can be explained as given next. Since these tests were all conducted at rated developed torque of 30 Nm (full-load condition), and since this torque is proportional to R_2/s , where R_2 is the equivalent rotor resistance reflected into the stator side and R_2 varies in value for each of the cases of one, two, and three removed bars, it follows that the running slip s , which yields the 30 Nm torque will have distinct and separate values for each of these cases. Hence, the LSB frequency $(1 - 2s)f$ will be different for each of the aforementioned “broken-bar” scenarios. These distinct and different LSB frequencies are clearly apparent in the stator current test FFT spectral results of Fig. 14.

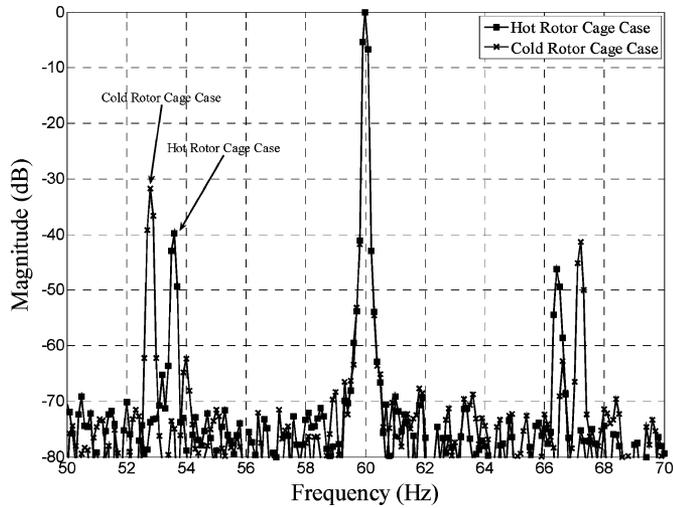
Fig. 15. Healthy rotor cage phase current FFT showing temperature dependence.

Meanwhile, it was also found that the sideband components are highly dependent on the rotor cage temperature, as illustrated for rotor cold and hot conditions in Fig. 15 (under healthy case with no broken/removed bars). This FFT spectrum of Fig. 15 again tends to allude to the uneven distribution of contact pressure and resistances between the rotor bars and the end rings. It should be observed that, for the same 30 Nm torque, the R_2/s ratio should remain the same for cold and hot rotor conditions. Despite the rise in rotor temperature, which at first glance would

lead one to think may lead to a rise in R_2 , the opposite seems to have happened here. This is because under hot condition, the value of R_2 appears to be lower due to higher contact pressure caused by bar metal expansion inside the bar holes in the end ring under heat. It follows that the corresponding running slip will be lower in value under hot conditions than in cold conditions to keep the R_2/s ratio constant. This is born out by the location of LSB frequencies in the FFT of the stator current spectra shown in Fig. 15 for these two conditions.

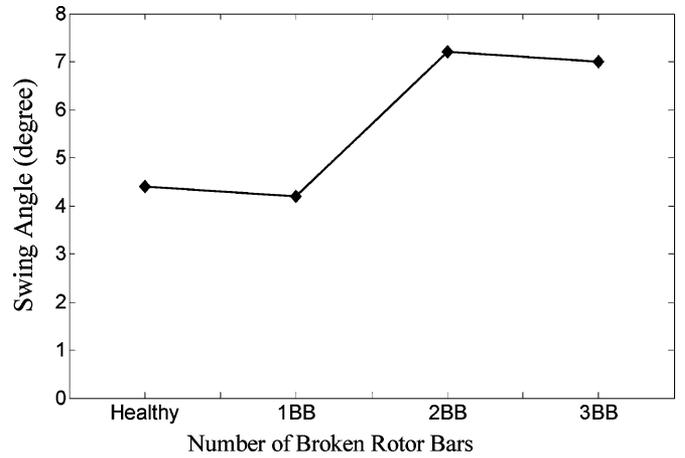
Fig. 16. Swing angle $\Delta\delta_1$ of healthy, one broken bar, two broken bars, and three broken bars.

The stator current test data for the healthy, one, two, and three removed bar (broken-bar) tests in conjunction with the corresponding motor terminal voltage test data were reexamined using the pendulous oscillation method [7]–[9]. Again, in this method [7]–[9], the time-domain profile of the angle between the stator current space vector, and the stator voltage space vector renders the so-called swing angle $\Delta\delta_1$, which constitutes the variable leading to the “broken-bar” fault index. Normally, under healthy rotor condition, $\Delta\delta_1$ is expected to be negligible. These swing angle findings are given for the healthy and one through three removed/broken bars in Fig. 16. Depicted in Fig. 17

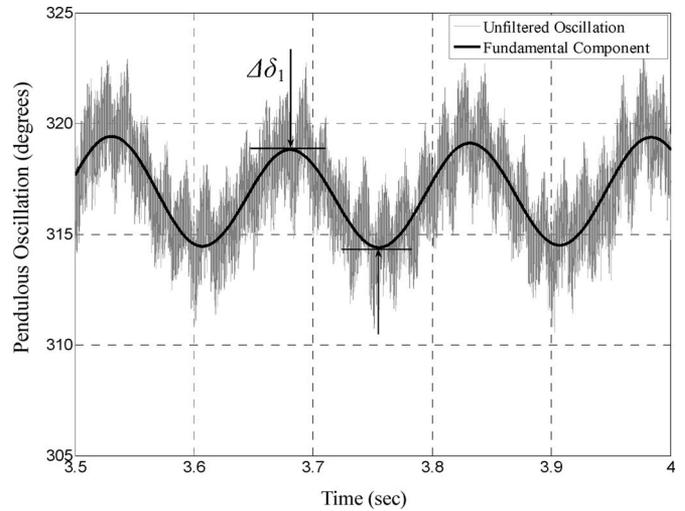
Fig. 17. Healthy rotor cage pendulous oscillation. Swing angle $\Delta\delta_1 = 4.4^\circ$.

is the time-domain profile of the pendulous oscillation angle for the healthy rotor cage case. It is expected that the peak-to-peak value of the pendulous oscillation known, namely, as the swing-angle $\Delta\delta_1$ in the healthy case should be negligible as shown earlier for the die-cast cage of Fig. 11. However, as can be seen from Fig. 17, this is not the case for this reconfigurable cage, meaning that there is a considerable distortion of the rotor magnetic field even in the healthy rotor cage case. This can only result from conductive discontinuities in the cage circuit “masquerading” as bar breakages. Depicted in Figs. 18–20 are the time-domain profiles of the pendulous oscillation angle for the cases with one, two, and three removed/broken bars under full-load 30 Nm operating conditions. Normally, one would have observed larger magnitudes of the pendulous oscillations as the number of removed bars increased from one to two to three. However, the expected monotonic trend demonstrated earlier in [7]–[9] did not hold here. This indicates problems with the contact resistances between bars and end rings, each time the rotor is disassembled and reassembled between the processes

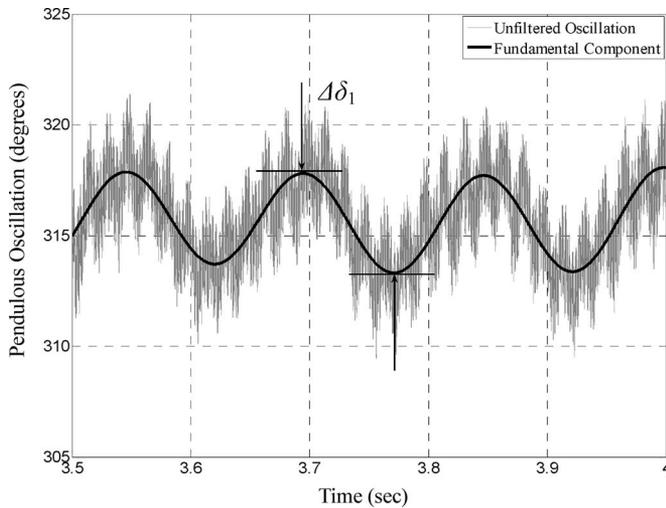
Fig. 18. One broken bar pendulous oscillation. Swing angle $\Delta\delta_1 = 4.2^\circ$.

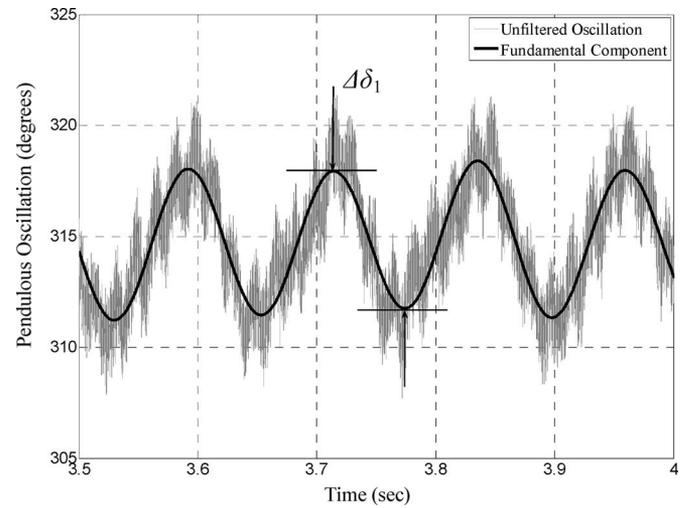
Fig. 20. Three broken bars pendulous oscillation. Swing angle $\Delta\delta_1 = 7^\circ$.

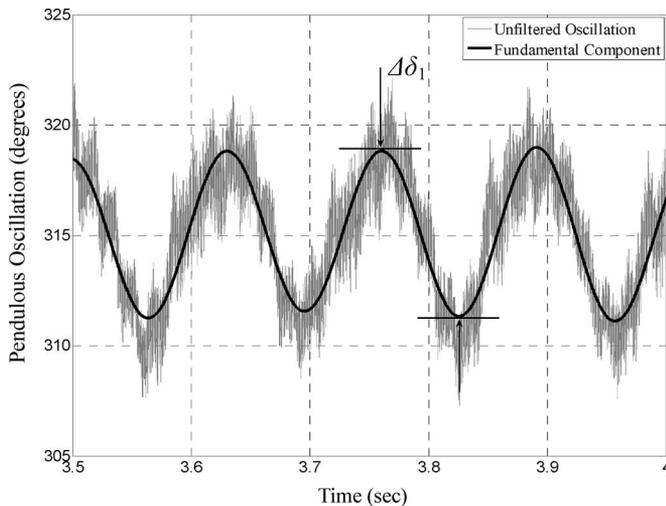
Fig. 19. Two broken bars pendulous oscillation. Swing angle $\Delta\delta_1 = 7.2^\circ$.
